# Linlithgow Public Realm Design Guide

SECOND DRAFT

### 1.0 Introduction

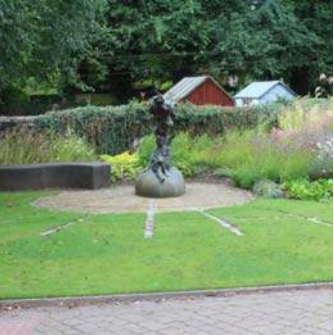
The Katie Wearie Sundial and associated green space provides an attractive focus to West Port arrival and meeting space.

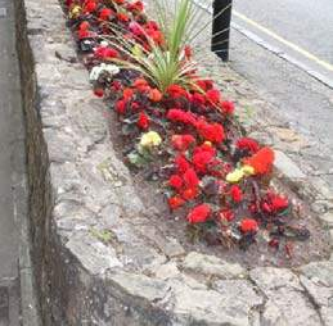
Stone walling and raised planter provides visual interest along street scene.

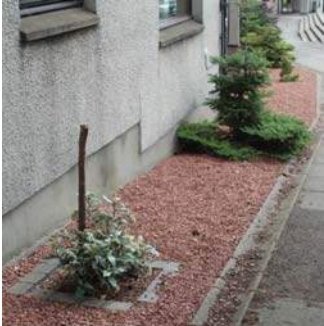
Inappropriate and damaged shrub planting within red gravel against modern flatted development falls short of Linlithgow's standard of attractive and well-maintained public planting areas.

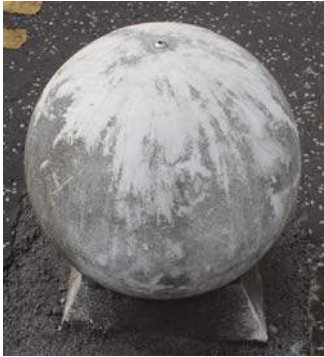
Large, cylindrical concrete bollards around West Port are a potential trip hazard and contrast with black cast-iron street furniture located elsewhere along the High Street.

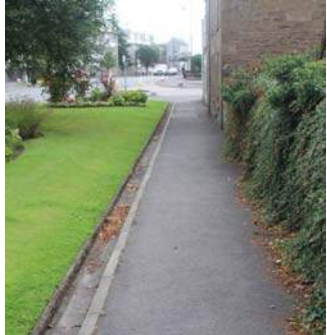
Opportunity for seating to be arranged along southern edge of green space at the Katie Wearie Sundial. This would allow users to address the floral planting and create more of a separation between the recreational seating area and the road.

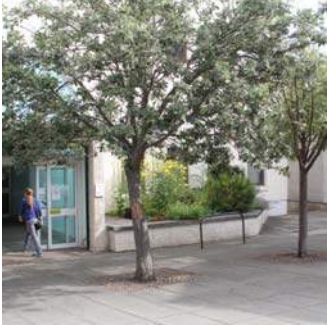
Area adjacent to the Health Centre currently under-utilised as recreational open space. Enhancing hard and soft landscape features would help establish this area as a recreational hub along the High Street.

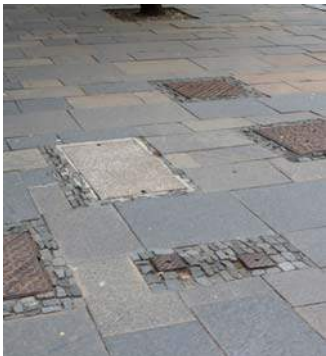
**Left:** Poor quality implementation and attention to detail detracts from quality of materials and leads to potential trip hazards

**Right:** Example of absence of tree grille in hard landscape and lack of underground support for tree.

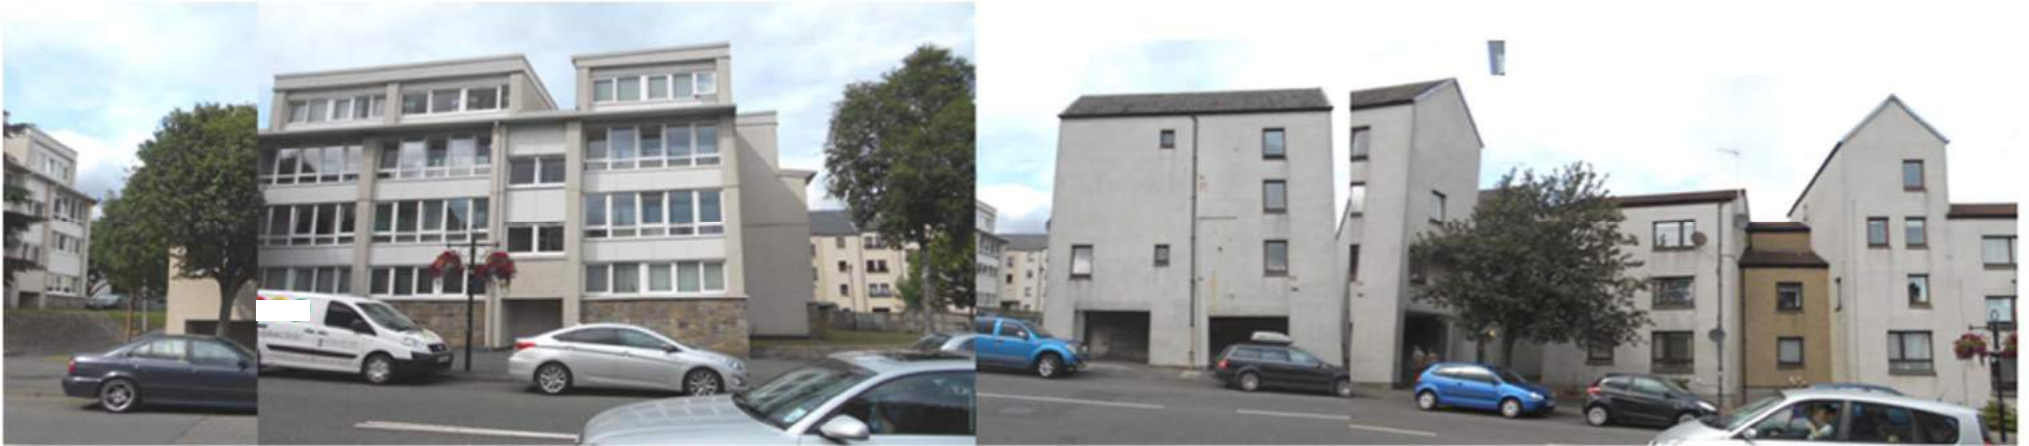
350-372 High Street:  
Flatted development  
circa 1970.  
Metal roof, UPVC  
windows.

Some repairs to  
rainwater goods and  
harling would improve  
this façade.  
Proliferation of satellite  
dishes detracts.

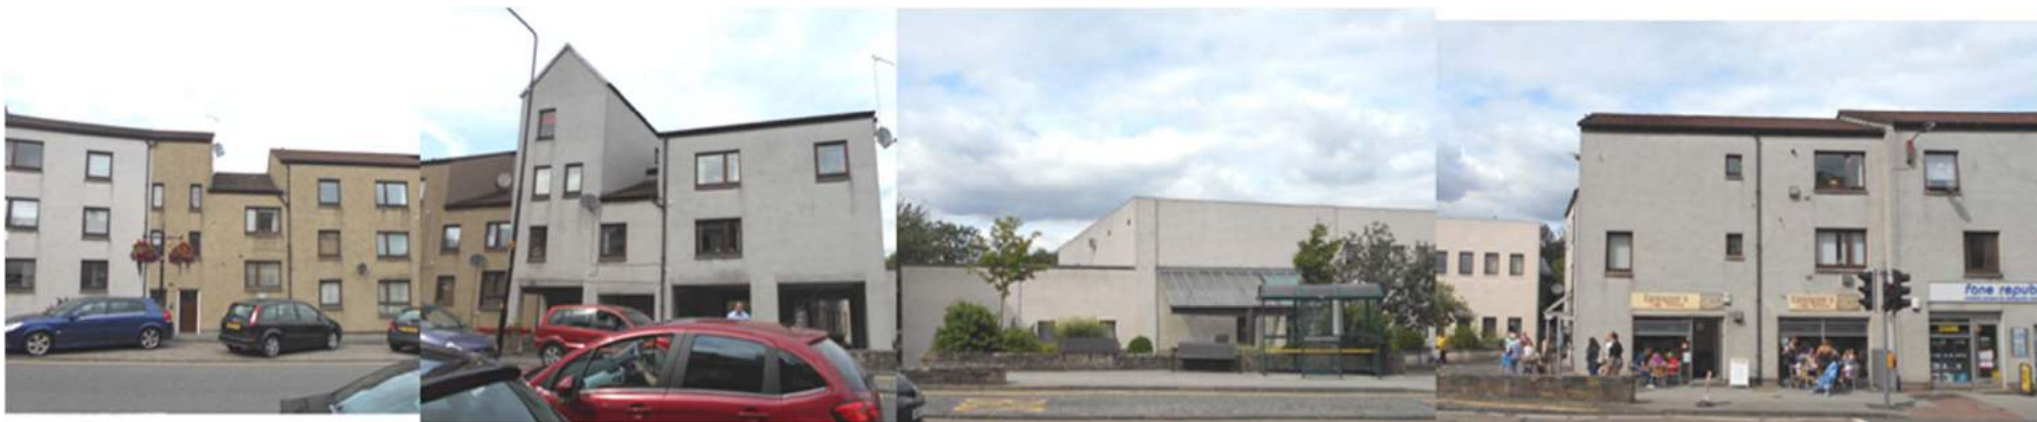
290-316 High Street:  
Flatted development  
circa 1975.  
Harled walls with tiled  
roofs, with slate on the  
4-storey block.  
Design includes  
colonnade over the  
pavement, historically  
a common feature of  
Linlithgow High Street  
largely lost by 1900.

Some repairs to  
rainwater goods and  
harling would improve  
this facade.  
Proliferation of satellite  
dishes detracts.

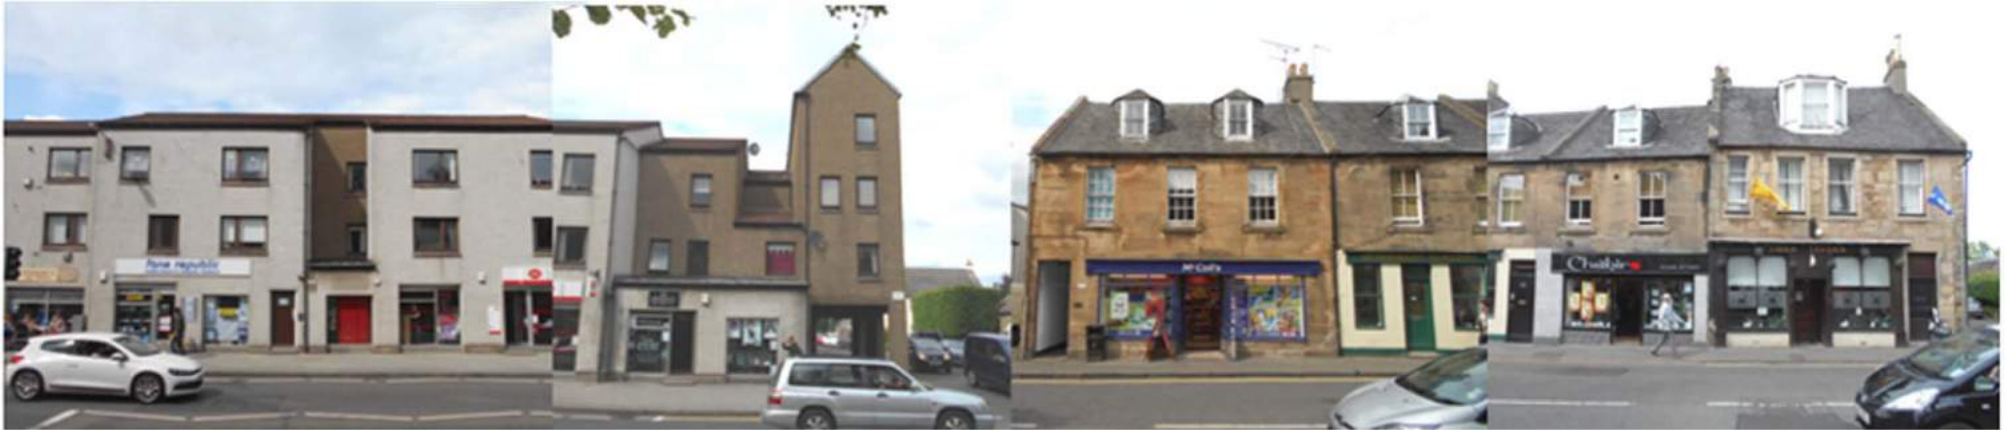
264-284 High Street:  
Retail/flatted  
development circa  
1975.

Salt damaged  
stonework, r.h. base

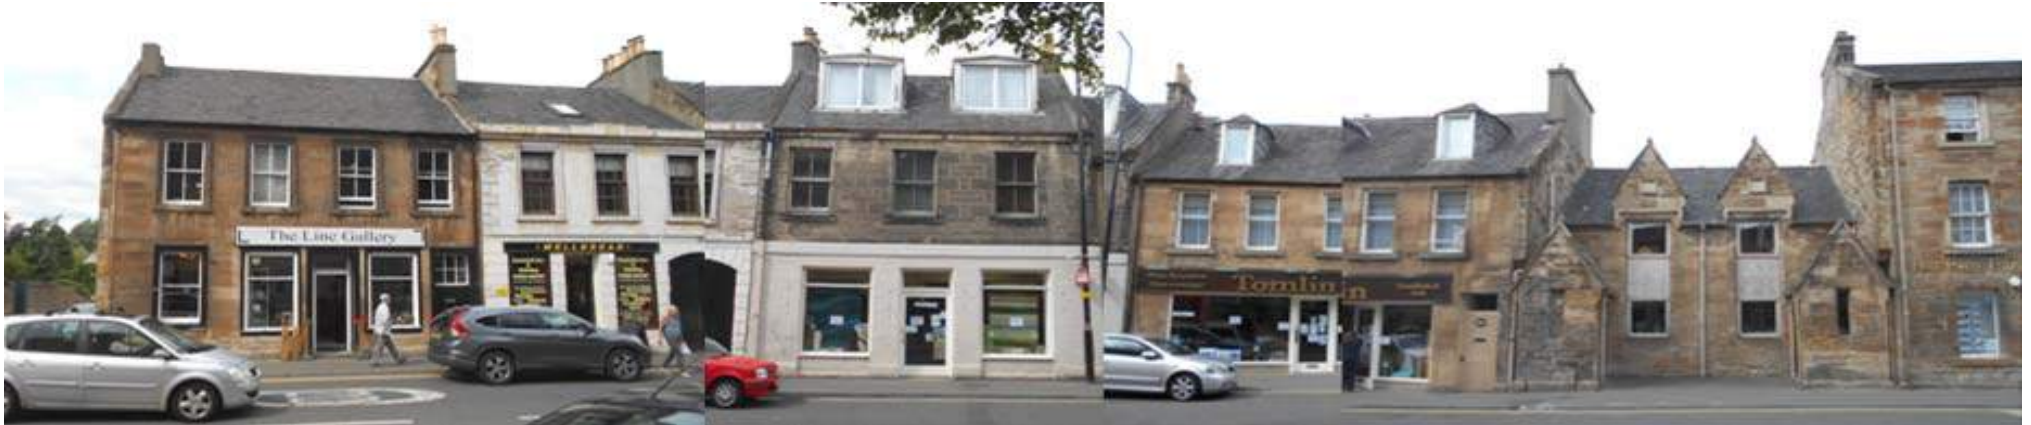
238 High Street:  
Listed category C.  
Early 19<sup>th</sup> century.  
Asymmetrical ground and.  
Regular but asymmetrical  
first floor.  
Sandstone walls, slate  
roof.  
Traditional 4-pane sash  
and case windows.

Missing chimney pots.  
Weeds growing at roof  
level.

Salt damaged stonework  
under windows.

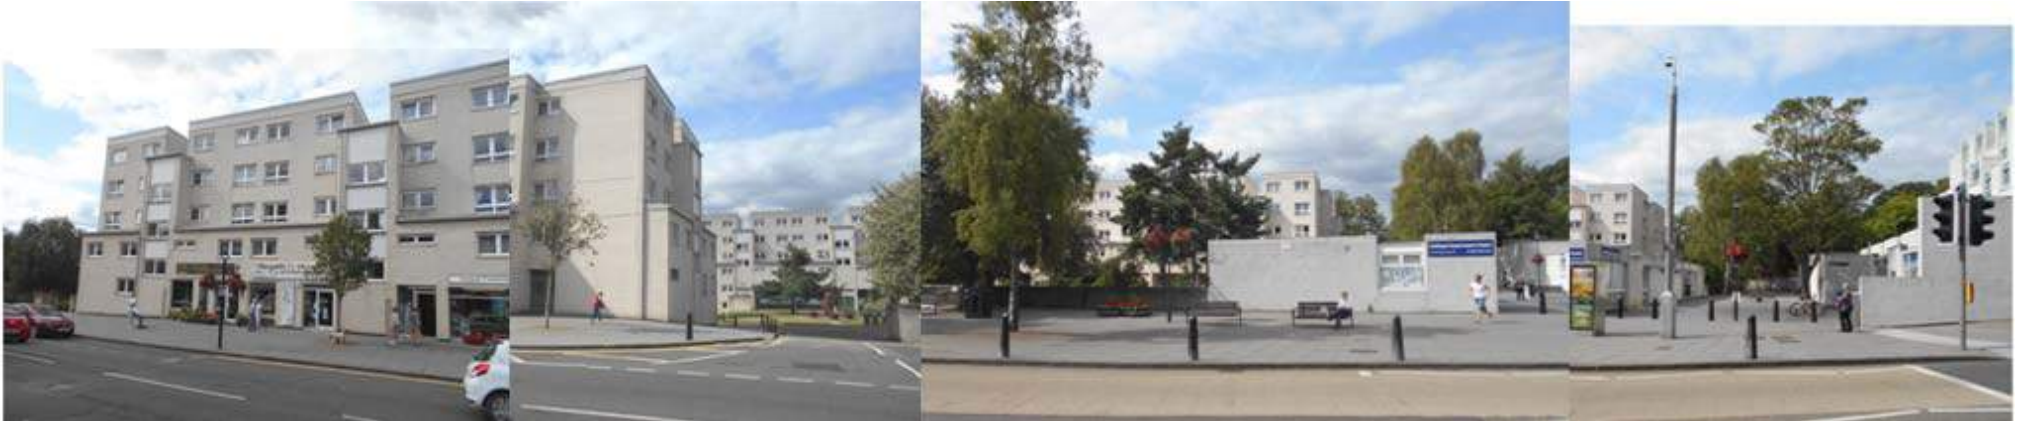
56-99 The Vennel:  
Retail and flatted  
development circa  
1970.  
Harled walls, flat roof.

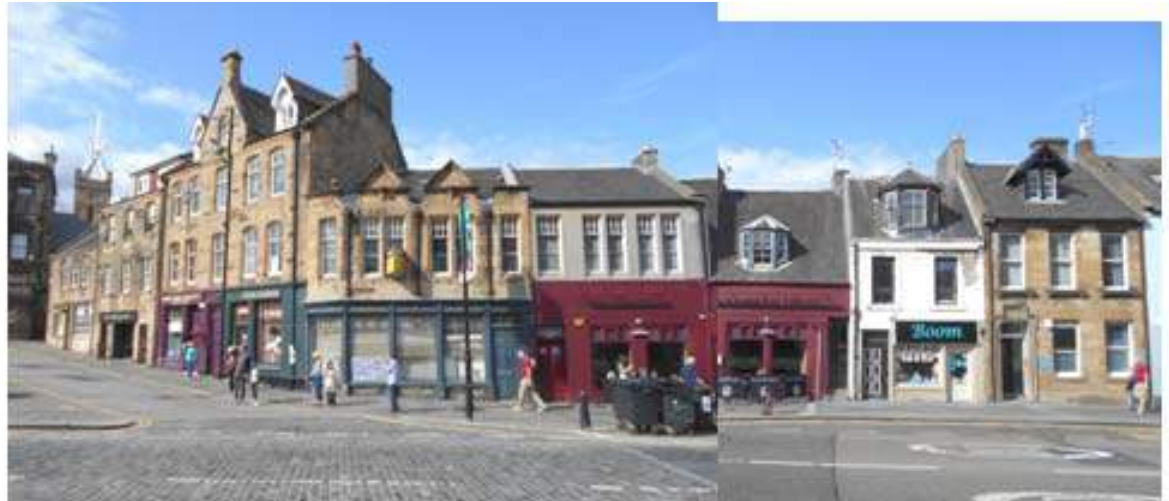
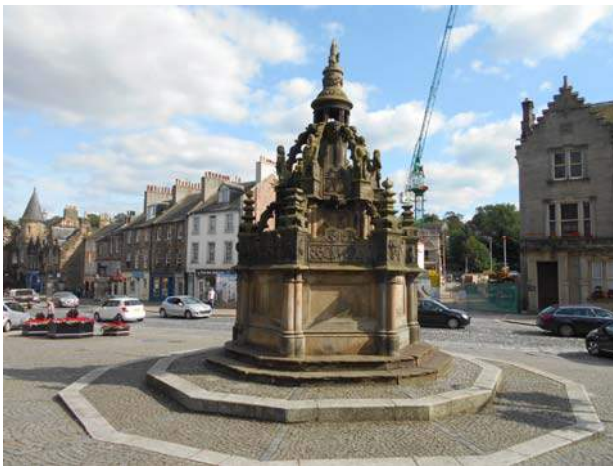
The fountain was repaired circa 2005, but is no longer functioning. To have running water in the Cross Well's fountain would add significantly to the value of this area as a public space.

114 High Street:  
Listed category C.  
19<sup>th</sup> century.  
Sandstone with slate roof.  
Curved on plan with pedimented facade.  
Dragon hopperheads.

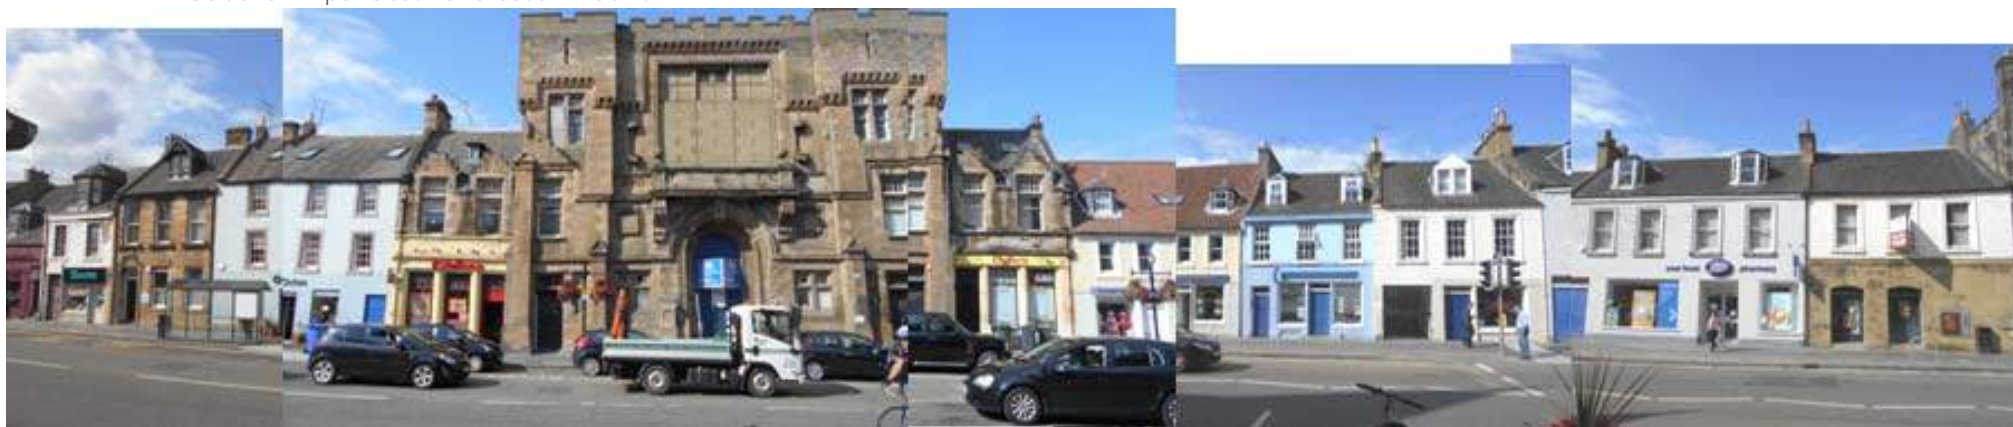
100 High Street:  
Listed category C.  
Early 19<sup>th</sup> century.  
Sandstone walls, slate roof.  
Asymmetrical ground floor, symmetrical upper.  
Traditional sash and case windows. Ornate projecting sills on upper floor.

Leaking rainwater pipe

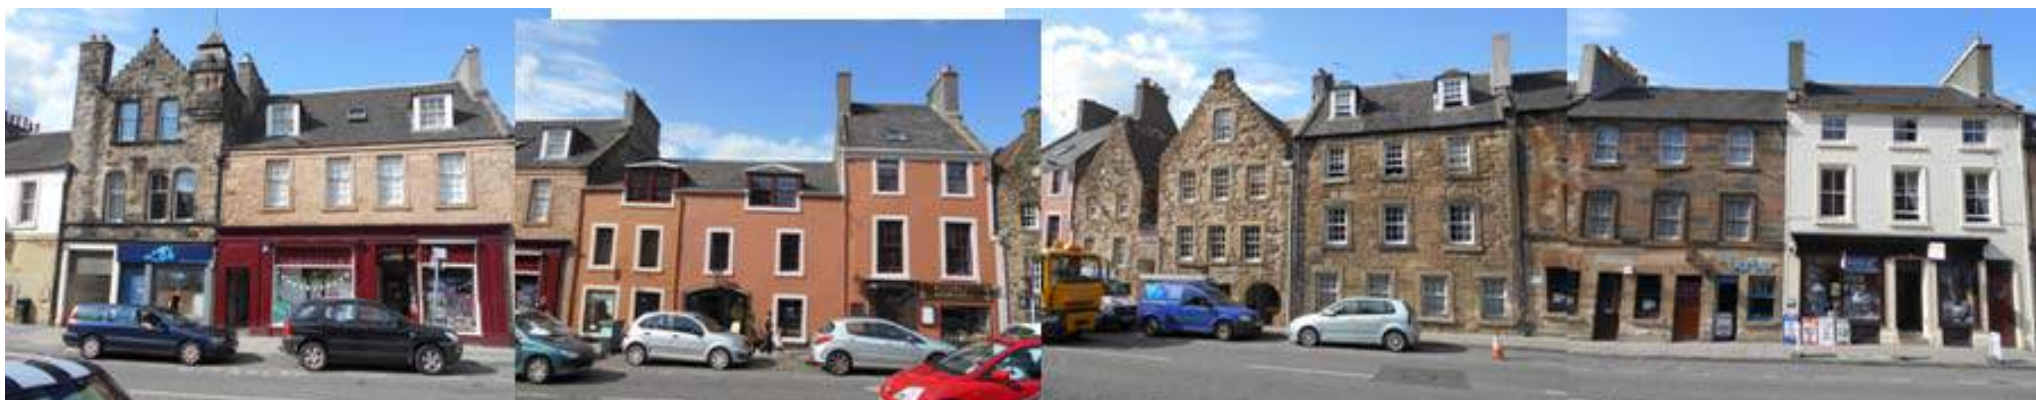
62-64 High Street:  
Listed category C.  
Carved date stone  
1881.

Salt-damaged stonework  
at base

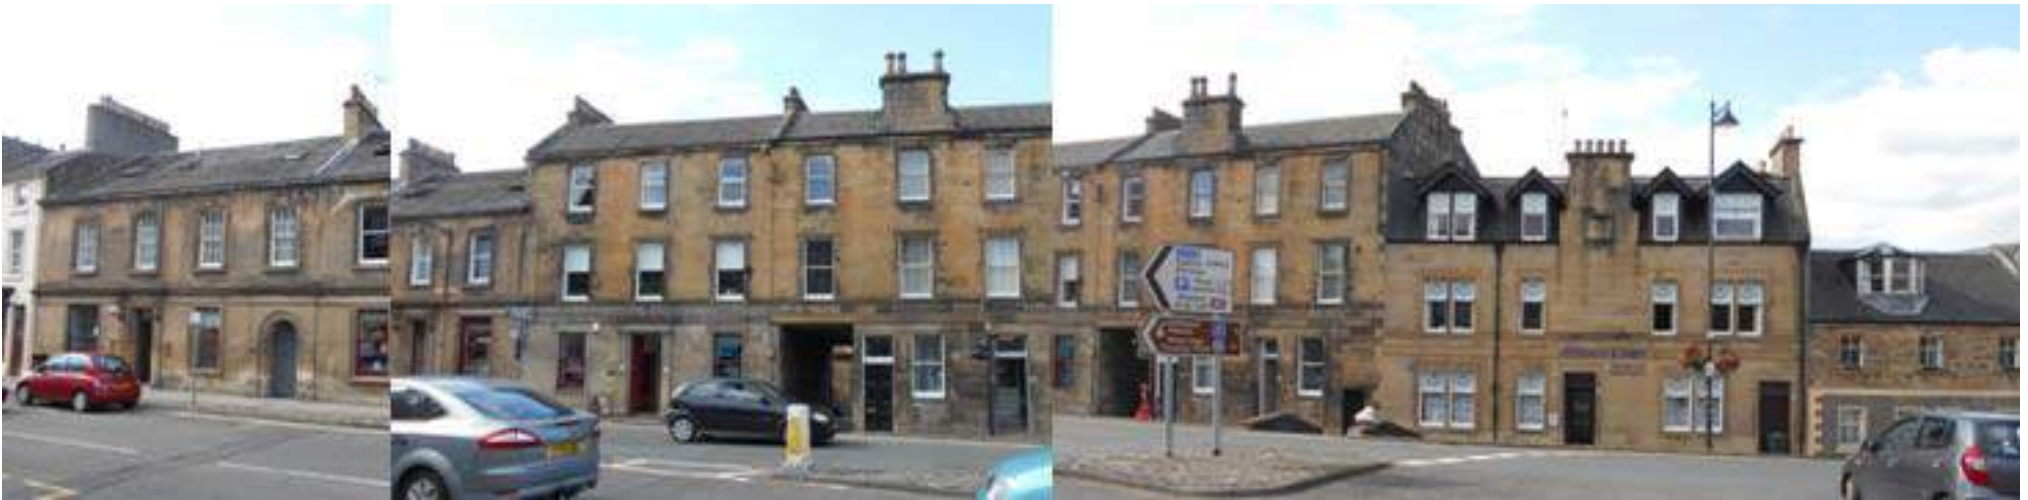
20-24 High Street:  
Listed category B.  
Circa 1840.  
7-bay facade with  
arched central pend.  
Sandstone and slate  
roof. Asymmetrical  
ground floor and  
symmetrical upper.  
Some 12-pane and  
some 2-pane windows,  
traditional sash and  
case.

Salt-damaged  
stonework at base.

Missing chimney cans.

Salt-damaged stonework under  
windows.

Leaking and absent rainwater  
pipes.

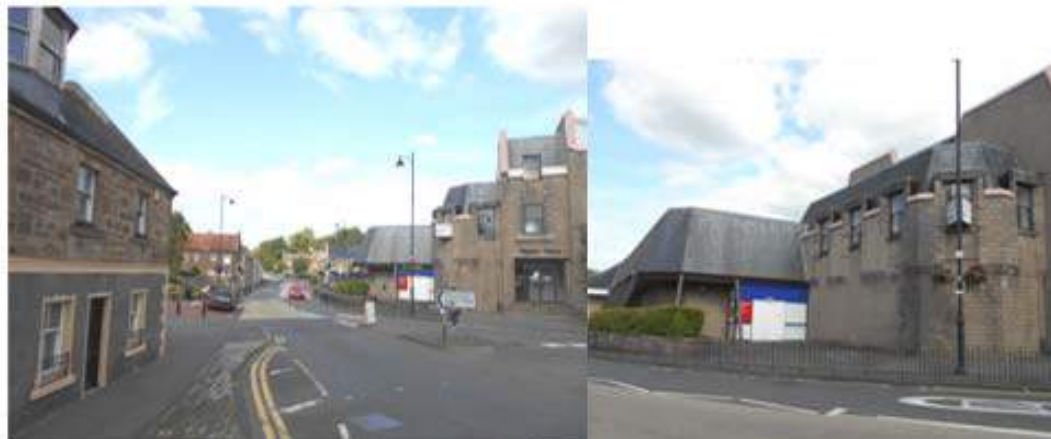
The Regent Centre offices and Tesco supermarket:  
Built 1983 on the site of the former Nobel explosives factory.

Carved foundation stone for the explosives factory dated 1902 is mounted adjacent to the supermarket entrance.

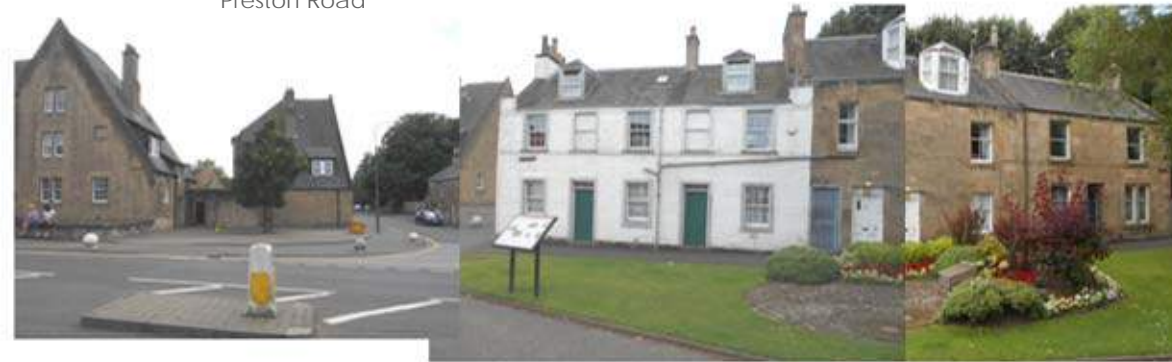
17-23 Westport: 19<sup>th</sup> century. Some original 12-pane windows, some modern 2-pane.

Leaking rainwater pipe

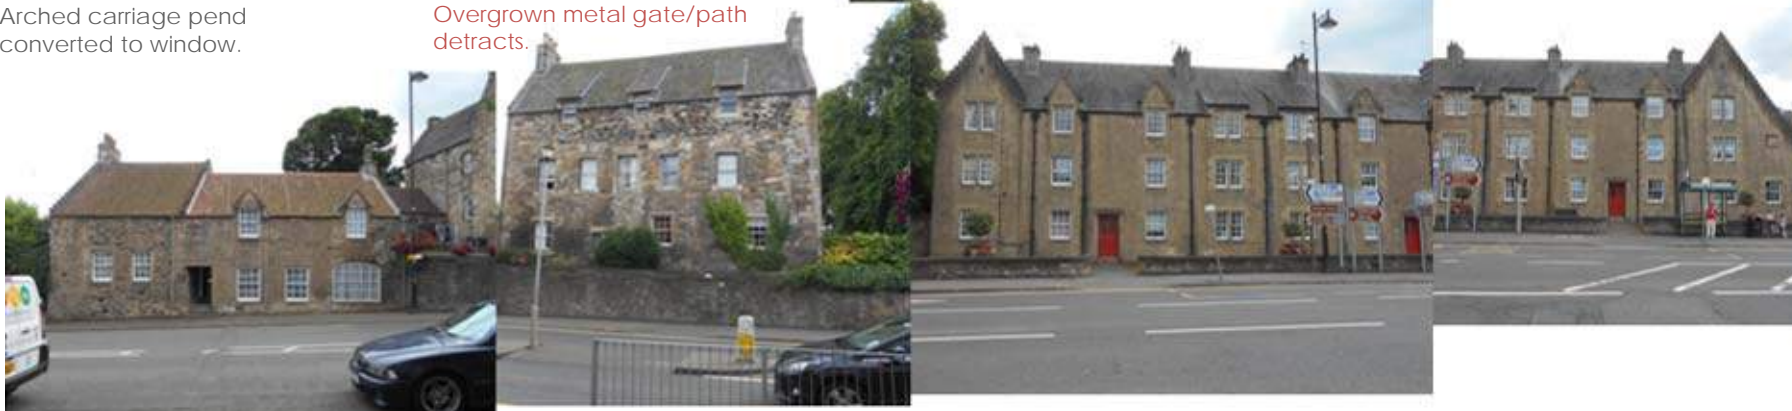
303-325 High Street. Listed category B. Tenement buildings set back from road, Designed in 1937 by W Scott in Scottish revivalist style. Carved plaque of Linlithgow coat of arms r.h gable. Crowstepped gables with scrolled skewputts and arrow slits.

Leaking rainwater pipes

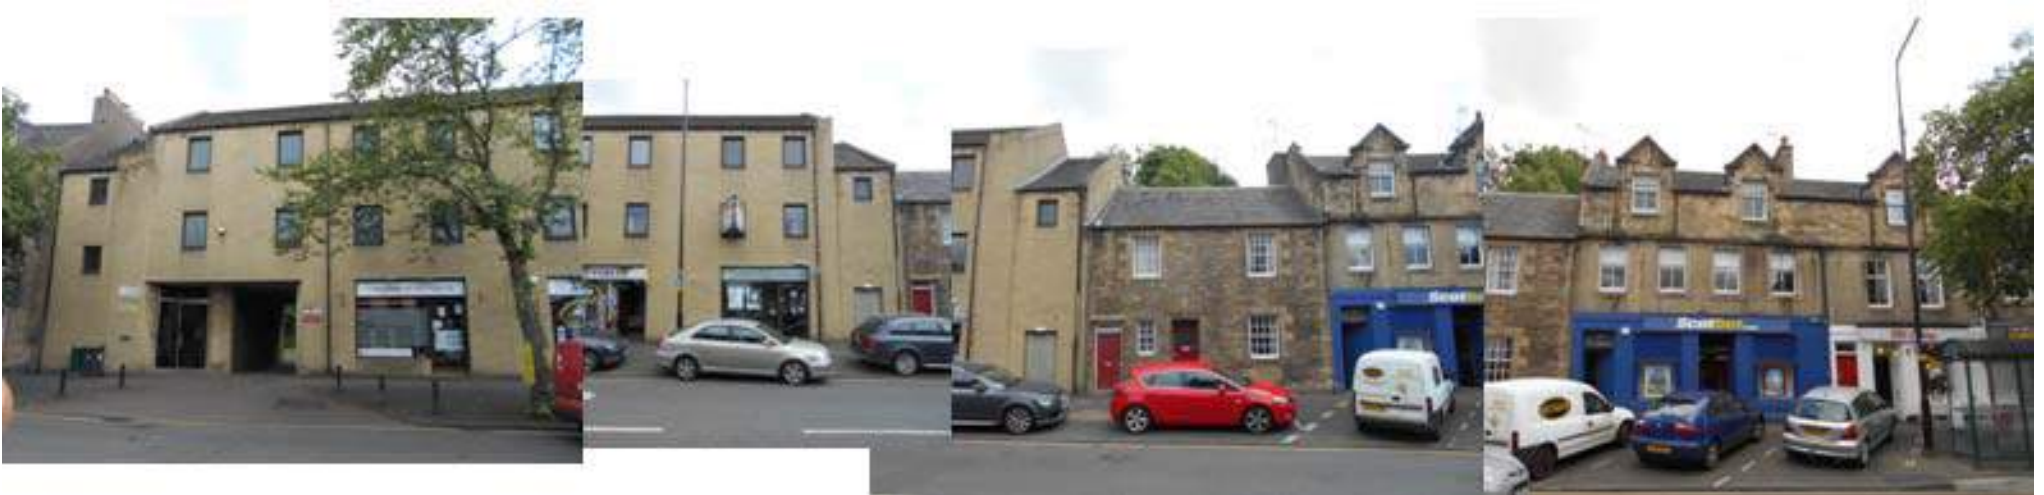
181-187 High Street:  
Circa 1980.  
Offices and retail.

Rainwater pipe  
damaged and leaking  
r.h. side.

Rainwater pipe missing  
an access cover,  
centre

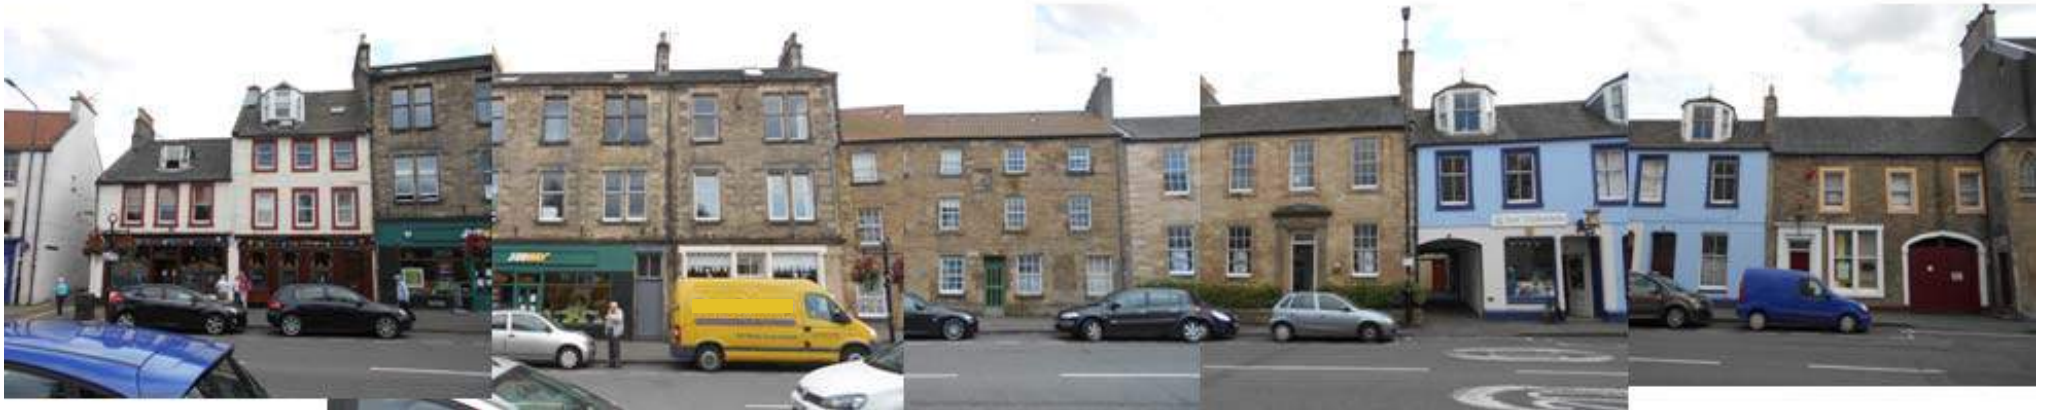
111,113,115 High Street:  
Listed category C.  
Football & Cricketers Inn.  
Circa 1800.  
Asymmetrical façade, rendered, lined and painted.  
Slate roof.  
Unused cast iron hanging sign bracket.

Leaking rhone and rainwater pipe.

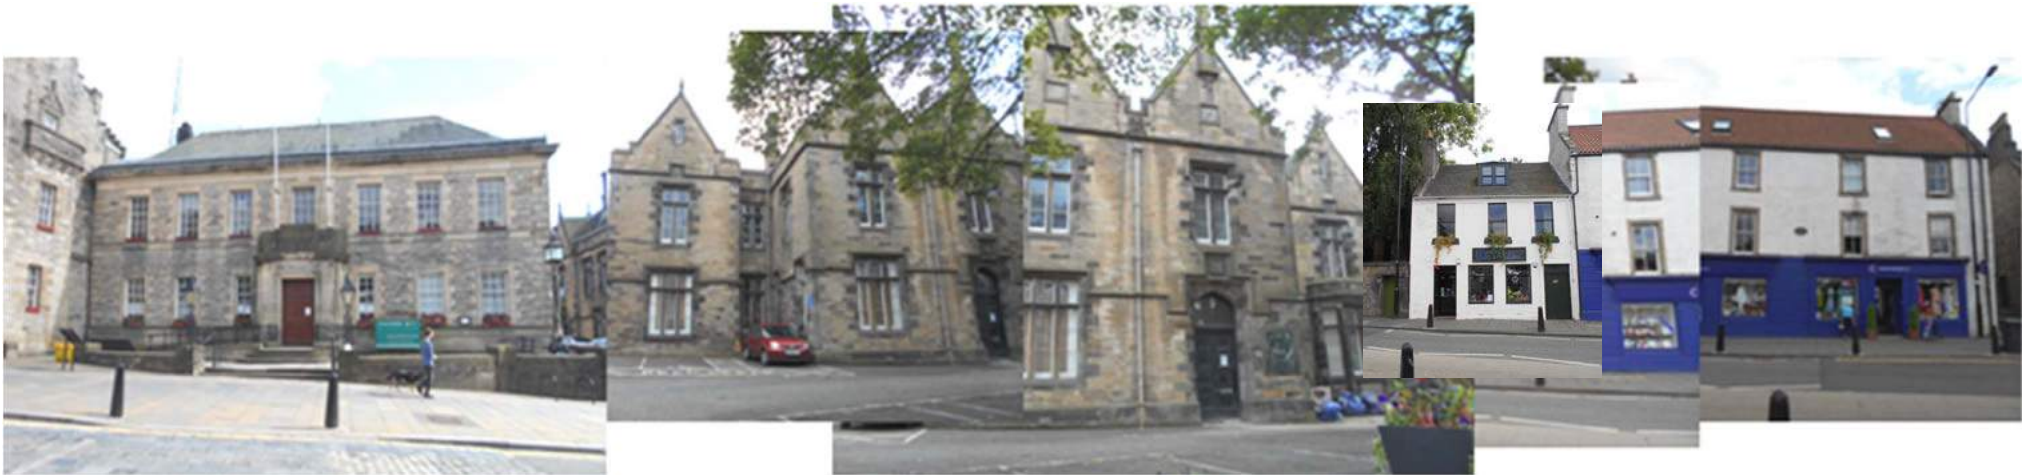
Linlithgow County Buildings:  
Listed category B.  
Designed in Neo-Georgian style by Dick Peddie & Walker Todd in 1935.  
Symmetrical façade.  
Sandstone, slate mansard roof.  
Traditional 12-pane sash and case windows.  
2nr flagpoles.  
Decorative streetlamps, including the Provost's Lamp at r.h.

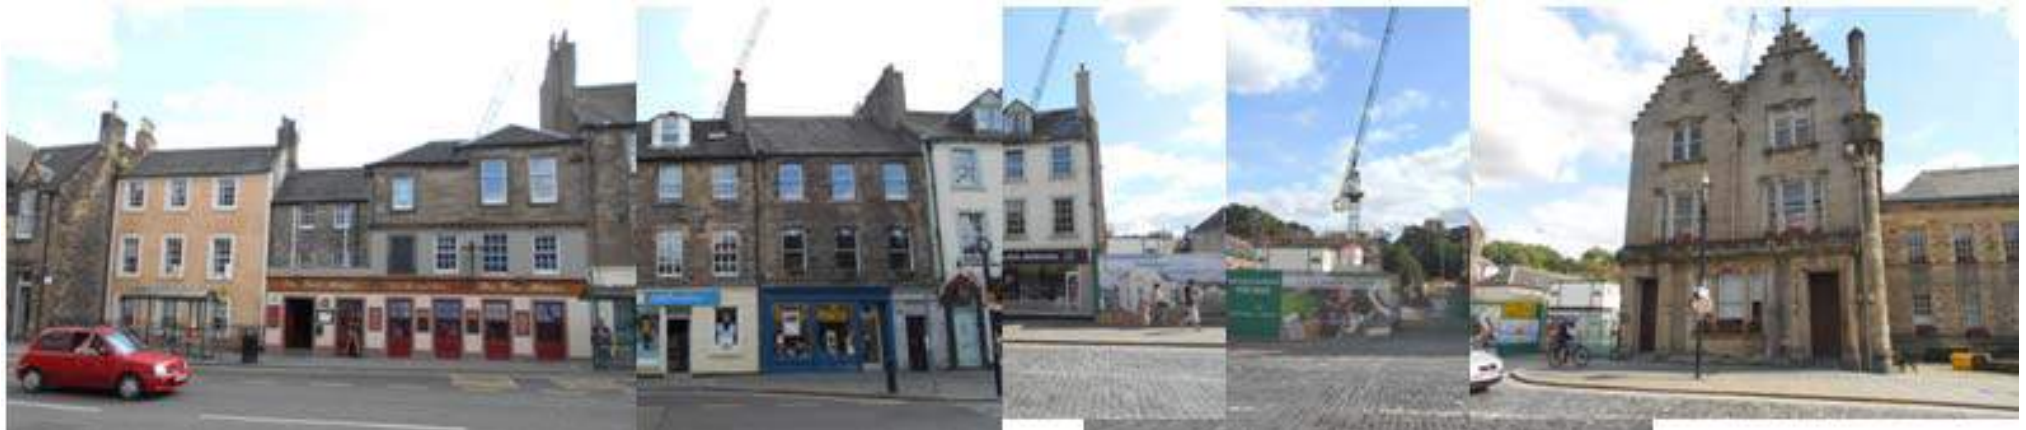
63 High Street:  
Listed category B.  
Late 18<sup>th</sup> century.  
Asymmetrical ground floor, Near symmetrical upper.  
Coloured harling walls, with slate roof.  
Traditional 12-pane sash and case windows, top storey windows smaller.  
Reproduction metal railings at road boundary.

Traditional timber shopfront requiring maintenance r.h. end to prevent loss of detailing. Detail already lost l.h. end. Shopfront improvement grant could help to repair this.

Leaking rhones.

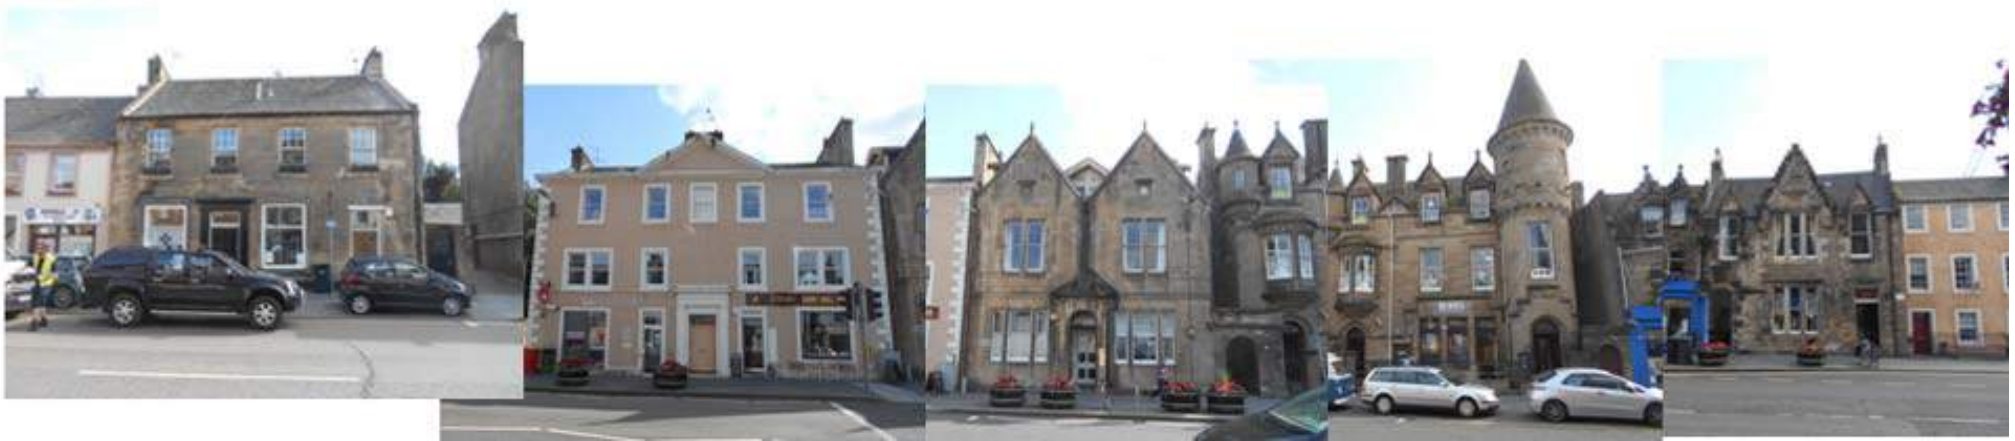
39-41 High Street:  
Listed category B.  
Early 19<sup>th</sup> century.  
Asymmetrical  
ground floor,  
symmetrical upper.  
Sandstone, Slate  
roof.  
Traditional sash and  
case windows, 6+1.  
1nr projecting sign.

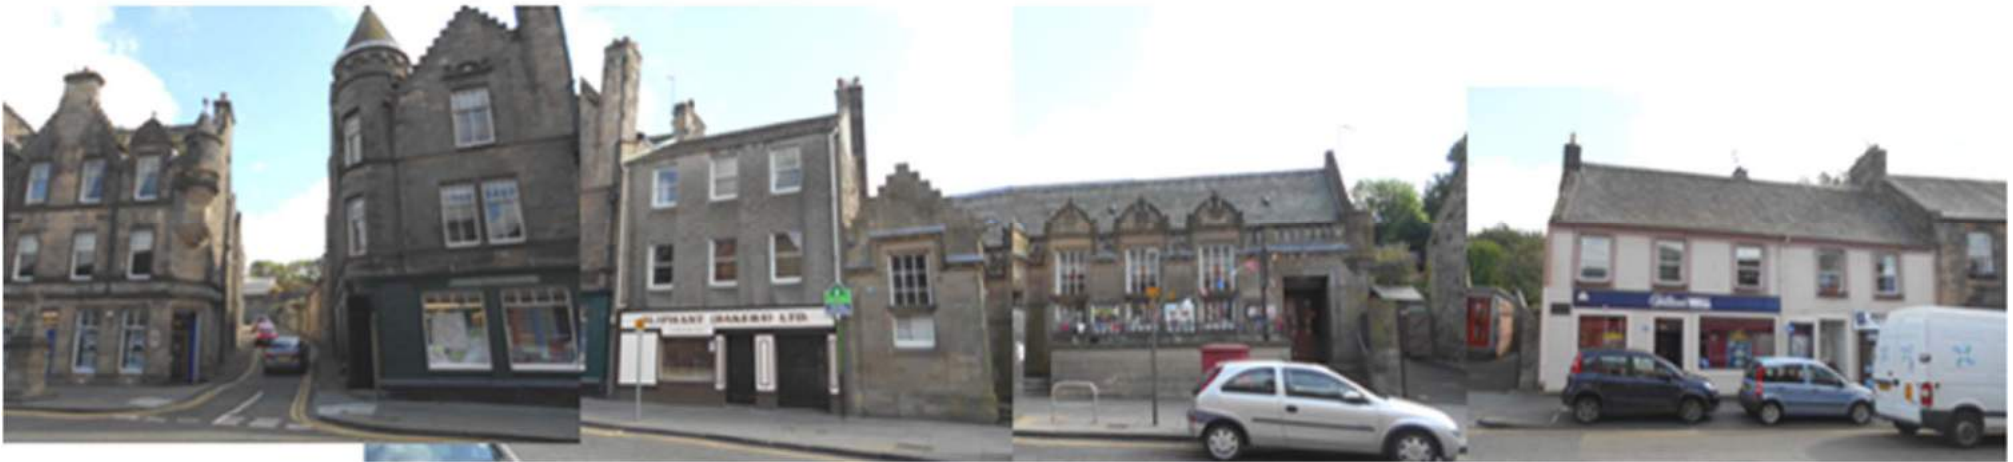
23 High Street:  
Listed category C.  
Baronial style with  
ball finials and  
crowstepped  
gables.  
Carved "St  
Michael's Place" ,  
date 1885 in  
tympanum, and  
"Hame's Best" over  
side entrance.  
Effective use of  
heritage paint  
colours on  
shopfront.

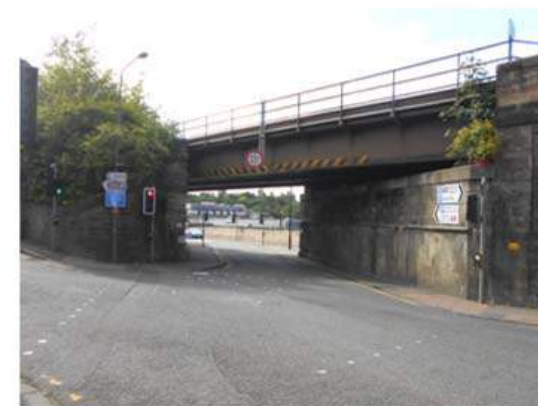
From Lowport to Highport. This area has suffered from lack of attention for many years.
