Linlithgow Loch SSSI SCM 2013 Scottish Natural Heritage

November 2013

Linlithgow Loch SSSI SCM 2013

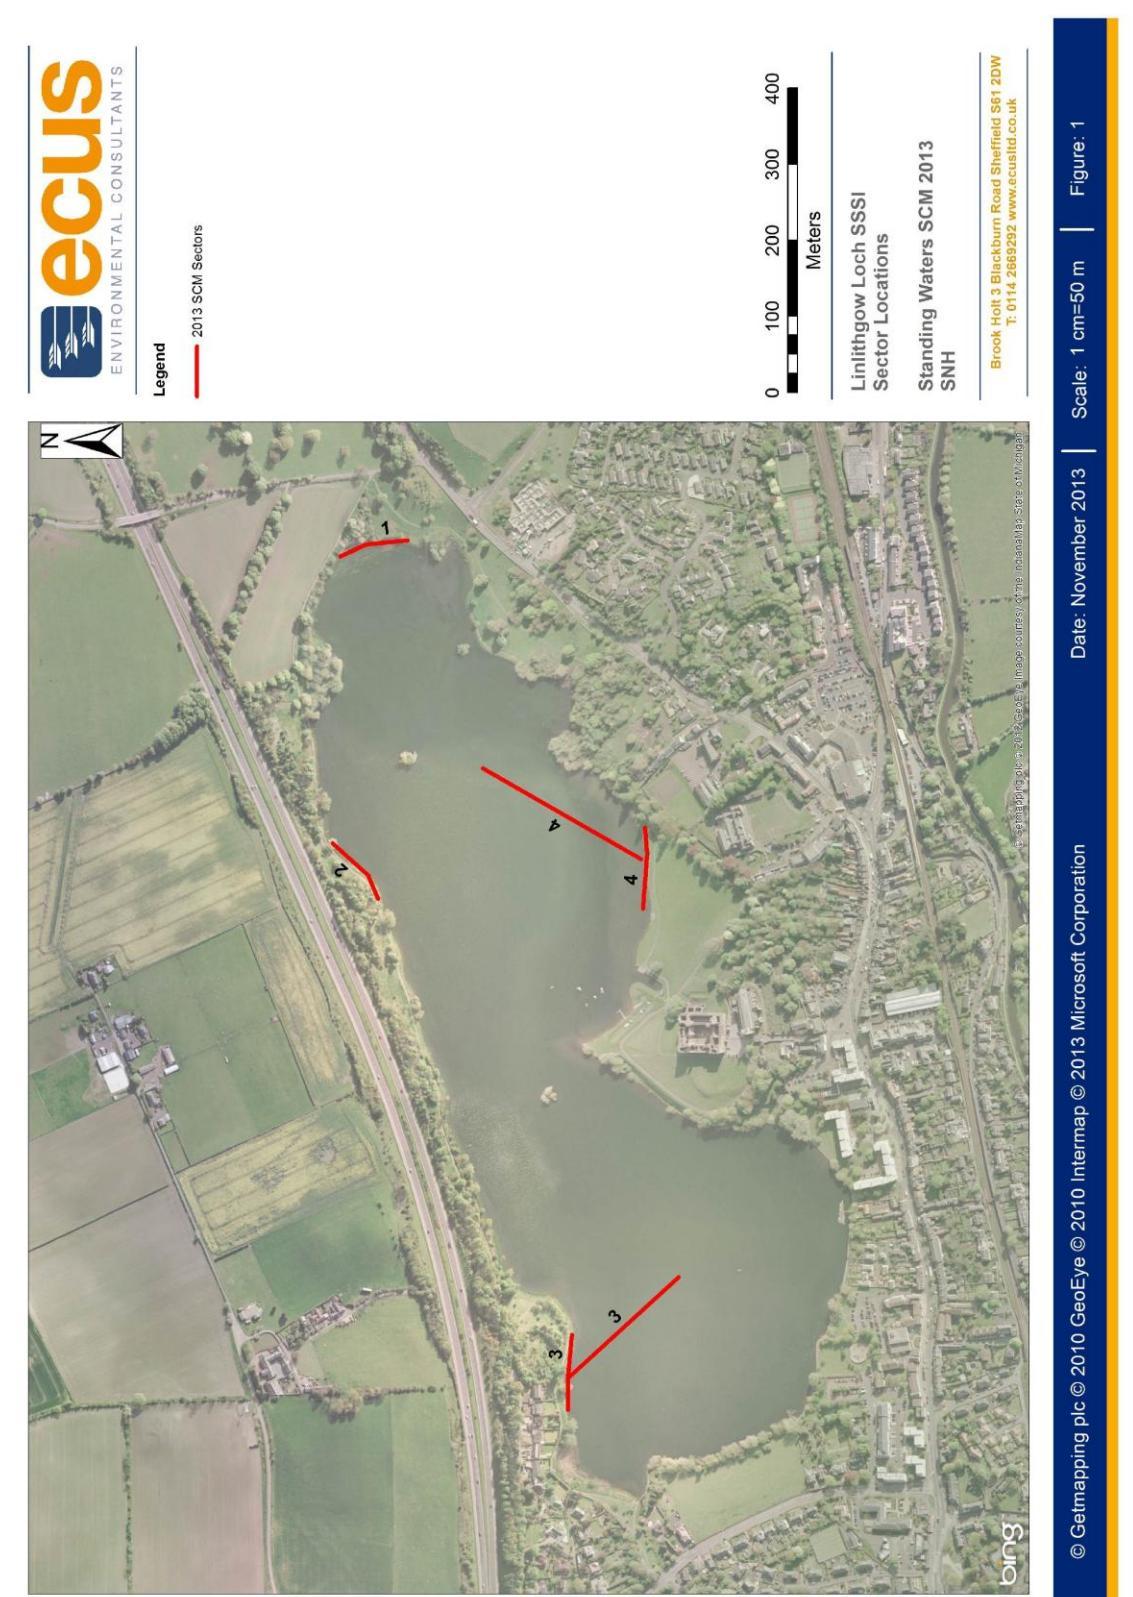
Appendix 1. Transect Locations

- 2.1.3 In 2013, four sectors were positioned around the loch, representative of the different habitats identified at Linlithgow Loch. Sectors 1 and 2 were located in the same position as in the 2004 SCM survey, with wader transects employed for direct comparison of the data. As recommended in CEH (2004), Sector 3 was relocated further north around the shoreline where there is much less shade. Due to the large size of the loch, an additional sector (Sector 4) was positioned by the palace. It soon became clear during the survey visit that there was very little vegetation in the shallows but much more vegetation offshore. It was therefore considered more valuable to conduct two boat transects for these new/repositioned sectors. In addition, the screen at the outfall was checked for stranded vegetation. Figure 1 (Appendix 1) shows the location of the 2013 survey transects.

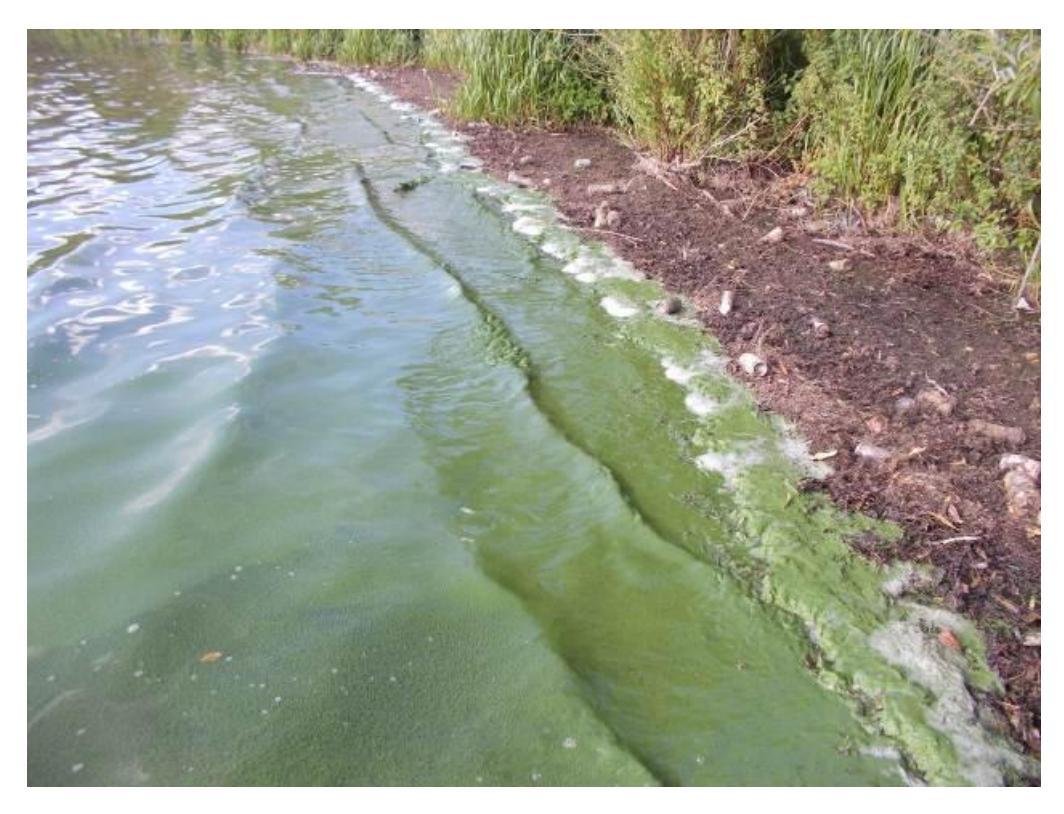
(iv) No excessive growth of cyanobacteria or green algae	Although secchi depths were reasonable in the middle of the loch, there was a blue-green bloom occurring at the time of the survey. This was most visible at the downwind eastern end of the loch, where there were dense accumulations (see photograph in appendix 2). Public health notices on display around the loch dated June 2013, suggesting that blooms are not uncommon at Linlithgow Loch but their frequency and duration are unknown. Blooms were reported as regular occurrences in the 2004 SCM.	Unfavourable, no change
Hydrology	(i) There should be a natural hydrological regime	The hydrological regime appeared to be natural with levels 0.2 m below maximum at the time of survey. There is a screen at the outfall to hold the fish in the loch, but apart from periodic blockage with vegetation this does not impede water escaping from the loch.	Favourable

Plate 3: Blue-green algae bloom washed up on eastern shore

- 4.1.4 Water quality remains the main concern at Linlithgow Loch. Although nutrient levels were not tested in 2013, nutrient levels and silt appear to remain artificially high, reflected in the blue-green algal blooms, blackened condition of much of the submerged vegetation and poor vegetation in the shallows. There is a need to identify and address the key nutrient inputs to the loch. To conclude, it is recommended that the eutrophic standing water habitat feature of Linlithgow Loch SSSI be classified as **UNFAVOURABLE NO CHANGE**. The macrophyte community has some indicators of natural eutrophic conditions, but may be declining whilst external pressures threaten the natural nutrient levels and hydrology.
